Zoetvlei Blue Crane Case: *summary to date*

The most dangerous power line in South Africa; MBH 694-61-94 to MBH 694-61-100

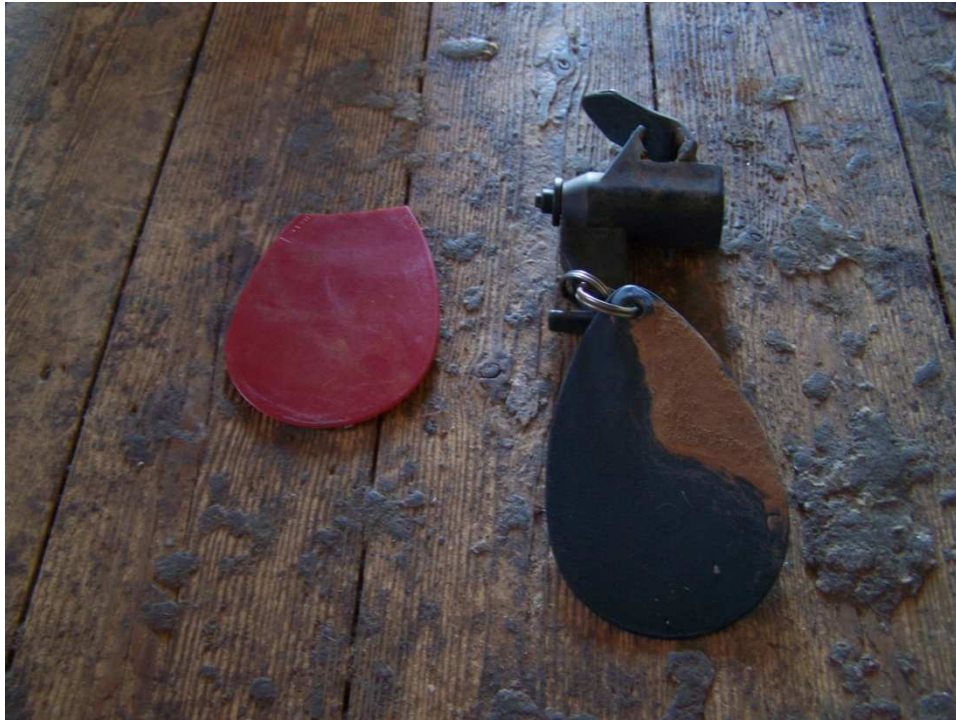
In 2003 Marina Beal, co-owner of Zoetvlei, observed that a particular stretch of power line was causing the death of a large number of Blue Cranes. This stretch of power line is 800m long and is between poles MBH 694-61-94 and MBH 694-61-100. It crosses the farm's Blue Crane sanctuary next to a very large water source. Marina contacted David Juliffe from the South African Crane Working Group (SACWG) and invited him to visit Zoetvlei and inspect the lines. Marina and David counted, on average, 16 dead Blue Cranes between each set of poles underneath the stretch of power line. David called it; "the worst case I have ever seen". David subsequently moved to Australia. In 2004 Marina contacted Riem de Beer of Manyano Power about the problem and he came to install flappers on the line (Fig. 1).

In April 2005, the lines were walked again and it became clear that the flappers were ineffective and were also braking off the lines; more fresh Blue Crane carcasses were found. Marina thus contacted Bradley Gibbons from the Endangered Wildlife Trust (EWT) and he visited the site. He was appalled by the amount of Blue Crane deaths and suggested that the lines be buried, because of its intrusion into the Blue Crane flight path. Bradley himself did not take this problem any further. By June 2006 another 25 Blue Crane carcasses were found.

Fig. 1: The flappers that were installed in 2004. Note that the left flapper broke off in the middle and that right flapper broke at the attachment.

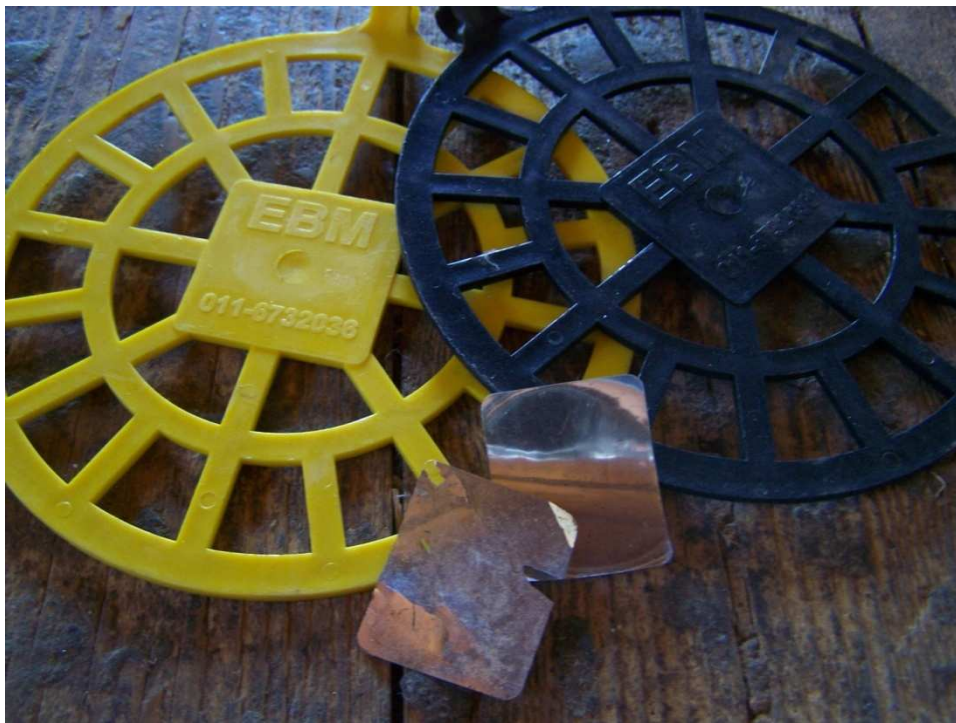
In June 2007, new devices were installed on the power lines with the help of Willy Els (Colesberg Eskom), because of the ineffectiveness of the flappers. These 'pods' were round shaped objects with reflection pads in the middle and were made to swivel in the wind (Fig. 2). The devices worked perfectly for the duration of 2007, but the reflection pads started falling off (they were glued onto the 'pods', Fig. 2). This was reported to the Eskom/EWT partnership, but no immediate action was taken. In April 2008, 13 Blue Crane remains were collected and the 'pods' started falling off the lines (it is also thought that these devices did not fall off the line, but were knocked off by the Blue Cranes). By July 2008 another 15 dead Blue Cranes were found and their carcasses collected.

Fig. 2: The 'pods' installed in 2007. These 'pods' worked perfectly until the reflective pads fell off. Note that the reflective pads are small, but still proved effective.

The second round of devices, the swivel 'pods' with reflectors, that Eskom installed seem to work very well until the reflective pads started falling off. If these pods are made to be more durable it could very much alleviate the problem. Also Eskom needs to inspect the lines that have been classified as problem lines in order to monitor the durability of the devices.

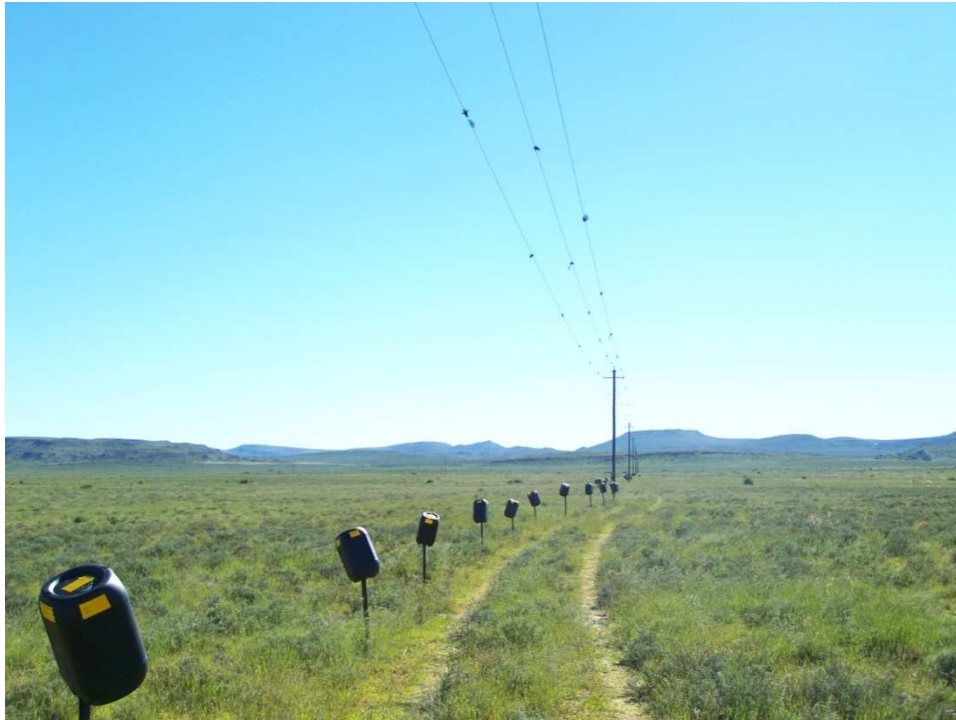
The lack of action from Eskom forced Zoetvlei to start installing home-made devices ('barrels') underneath the lines in July 2009 (Fig. 3). Previous observations indicated that Blue Cranes do not collide with power lines spun above fences, so the thinking was that the 'barrels' would have the same effect. These 'barrels' were normal 25 litre, black plastic drums with the original white stickers on them. While installing the 'barrels' another 7 Blue Crane carcasses were collected. Unfortunately in December 2009 another 18 Blue Crane remains were found underneath the line, even though the 'barrels' were installed. Also two Blue Cranes died directly above a farm gate.

Thus, in December 2009 the 'barrels' were altered to include reflective tape and glow-in-the-dark paint (Fig. 3). Since then there has not been any new Blue Crane deaths and everything is going well for the species at Zoetvlei. However, the main time during which Blue Crane deaths are observed is in the winter (July - October). Time will tell if the altered 'barrels' are effective.

Fig. 3: The altered home-made 'barrels' with reflective tape and glow in the dark paint installed in December 2009 underneath the power lines.

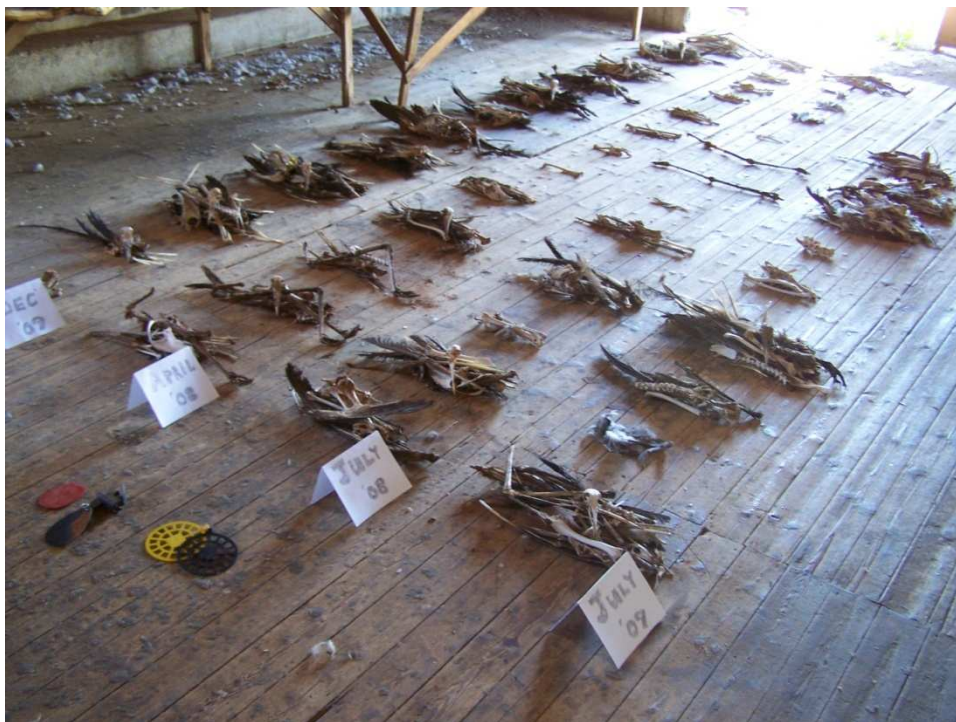
A minimum of 78 Blue Cranes have died in the last three years at Zoetvlei (Table 1; Fig. 4). All these deaths were from colliding with the same stretch of power line; MBH 694-61-94 to MBH 694-61-100. We feel that this is totally unacceptable and would like to propose possible solutions.

Fig. 4: Fifty three of the 78 Blue Cranes that died at Zoetvlei over the last three years. Note that this is the minimum amount and that the real amount is probable closer to 150.
